Greenville | Paris | Sulphur Springs

FACILITIES  
MASTER  
PLAN

March | 2026

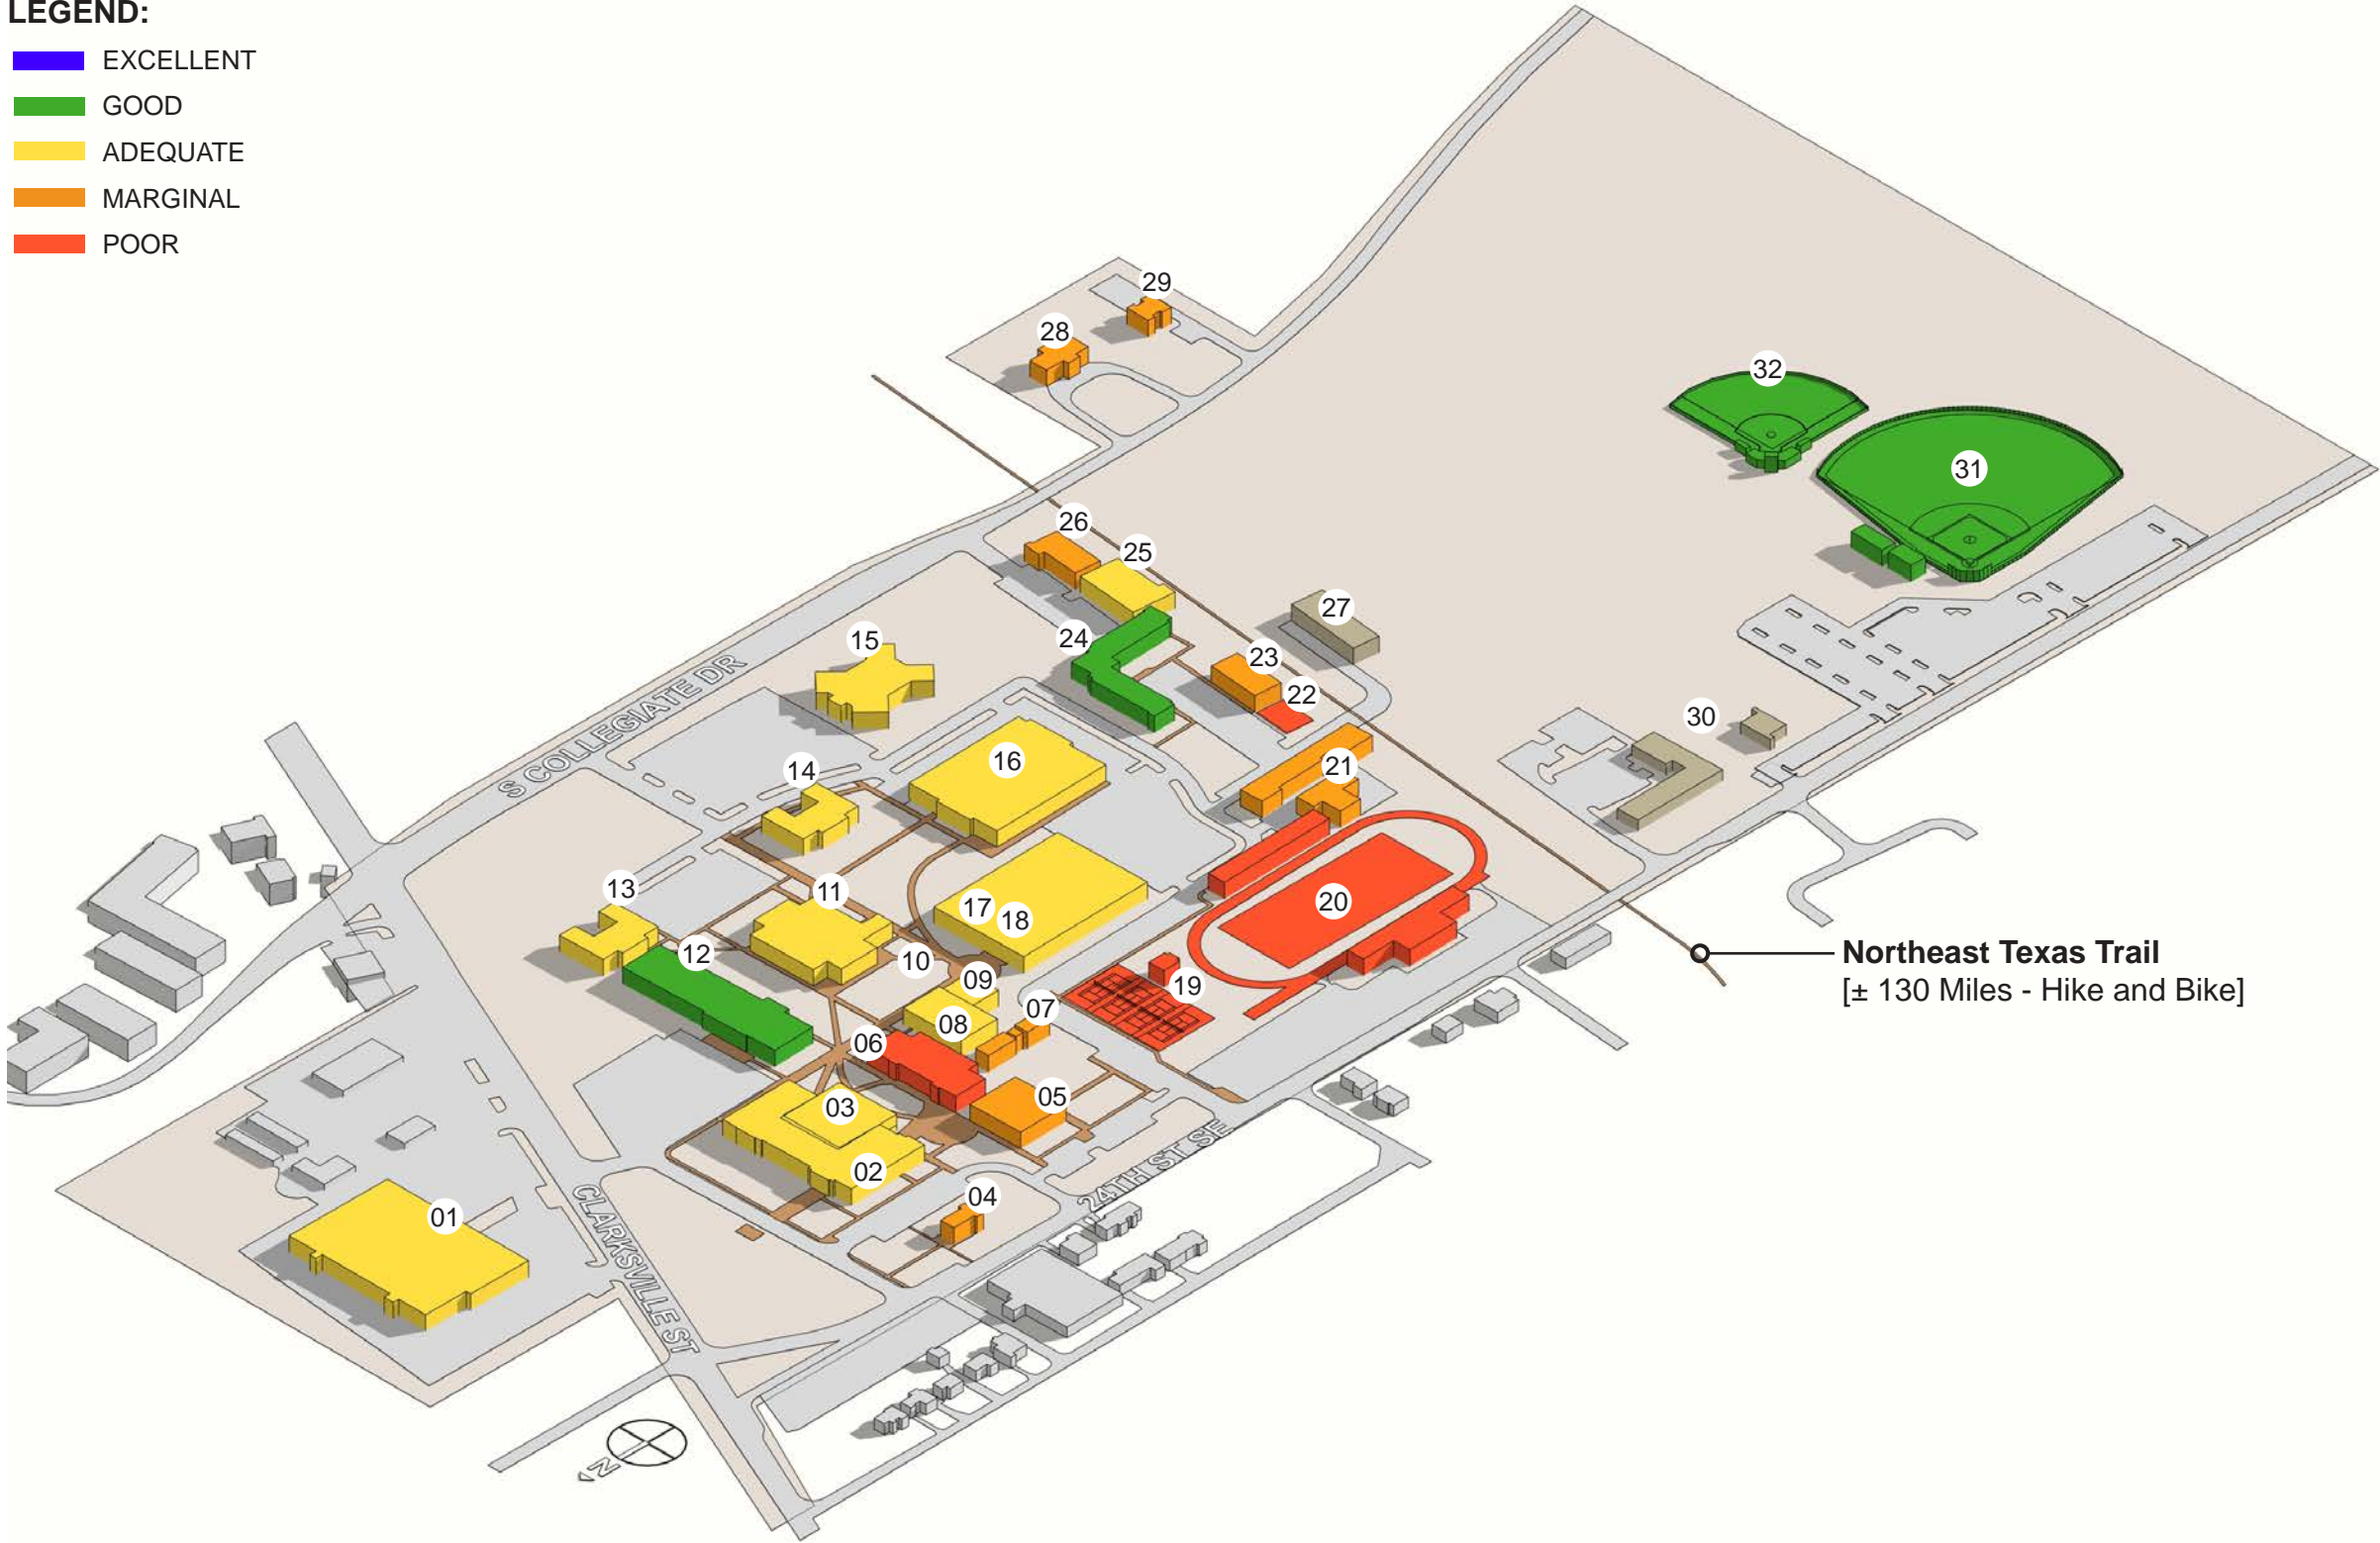
- LEGEND:**
- EXCELLENT
  - GOOD
  - ADEQUATE
  - MARGINAL
  - POOR

1. Bobby R. Walters Workforce Training Center
2. Williams Administration Building (Ray E. Karrer Theatre)
3. Frank Grimes Center
4. DeShong Chapel and Carillon Tower
5. Mayer Center for Musical Arts
6. Old Gymnasium
7. Mechanical Building
8. Alford Center
9. College Store
10. Aikin Plaza
11. McLemore Student Center and Campus Police Office
12. Math & Science Building
13. Hatcher Hall
14. Thompson Hall
15. Hunt Physical Education Center
16. Applied Science Center
17. Aikin Archives
18. Rheudasil Learning Center and Educational Opportunity Center
19. Tennis Courts
20. Noyes Stadium
21. Plant Operations & Maintenance
22. Volleyball Courts
23. Annex 4 (Sonography)
24. South Campus Residence Hall
25. Art Building
26. Annex 1
27. Bus Barn
28. Talent Search/Upward Bound
29. Gabbert Building/SBDC/RSVP
30. 1355 24th St Buildings
31. Hub Hollis Field
32. Softball Field

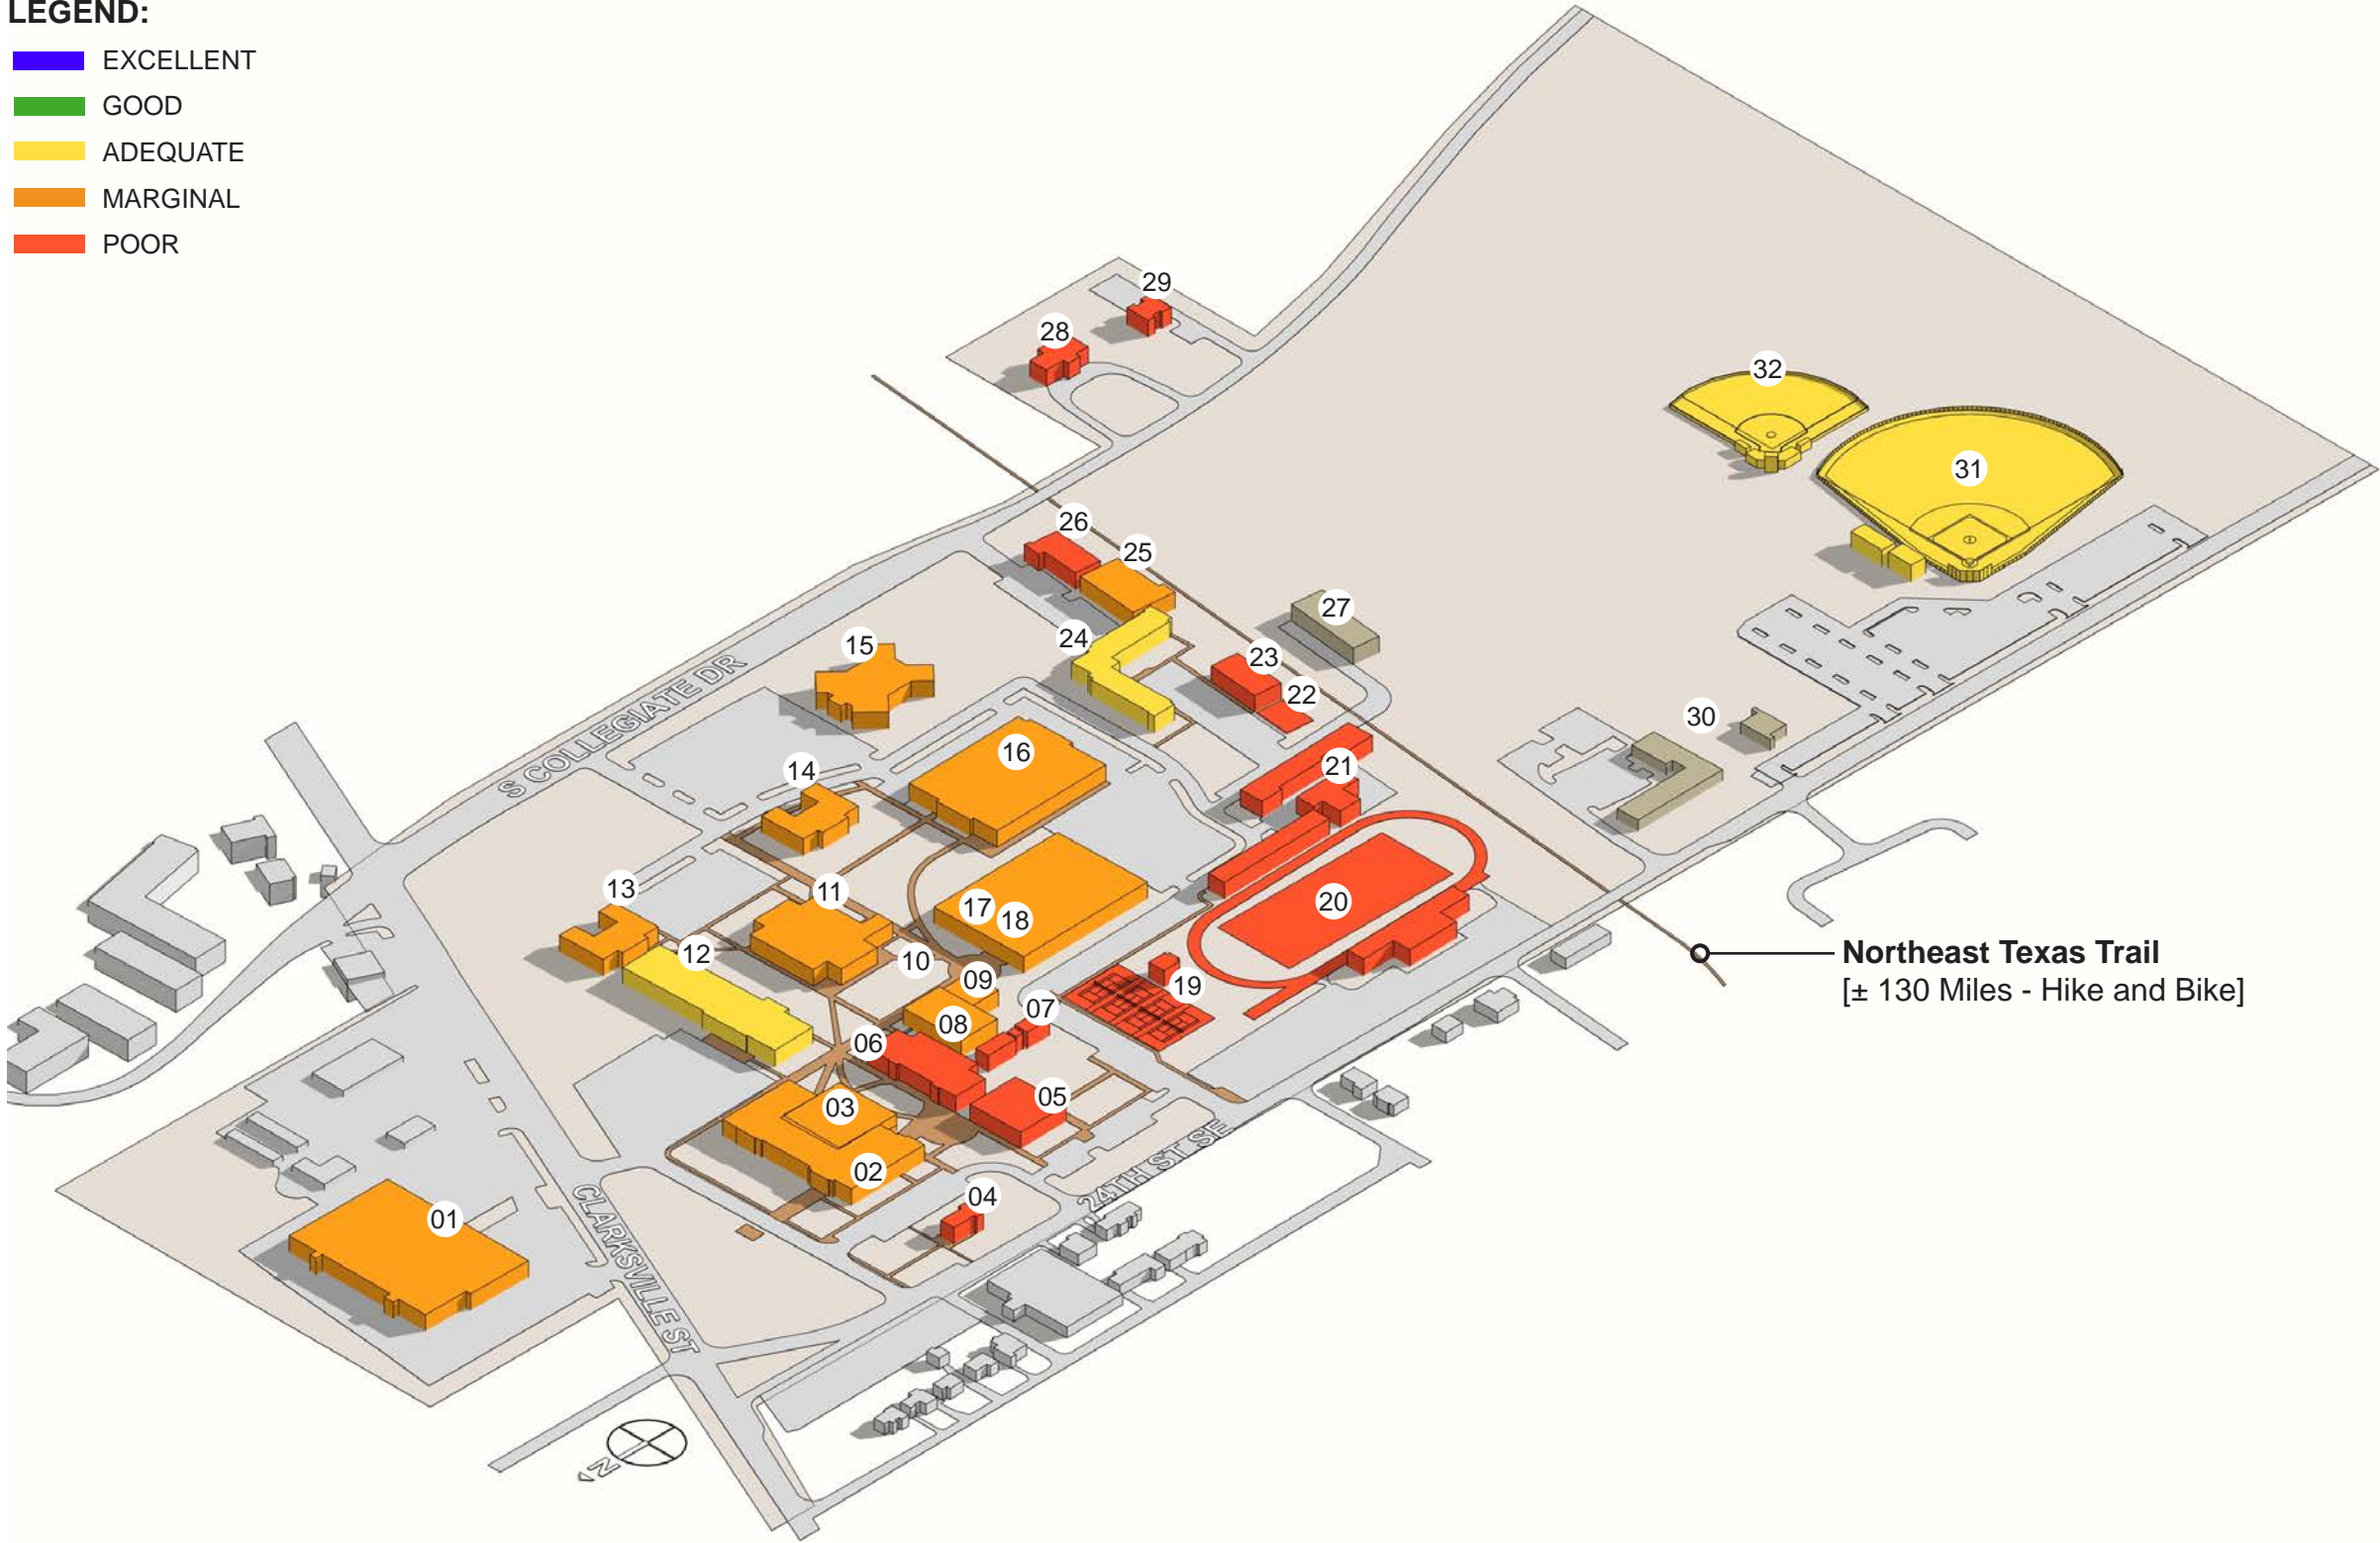
# FACILITIES ASSESSMENT: 5+ YEARS

- LEGEND:**
- EXCELLENT
  - GOOD
  - ADEQUATE
  - MARGINAL
  - POOR

- EXISTING BUILDINGS:**
1. Bobby R. Walters Workforce Training Center
  2. Williams Administration Building (Ray E. Karrer Theatre)
  3. Frank Grimes Center

4. DeShong Chapel and Carillon Tower
  5. Mayer Center for Musical Arts
  6. Old Gymnasium
  7. Mechanical Building
  8. Alford Center
  9. College Store
  10. Aikin Plaza

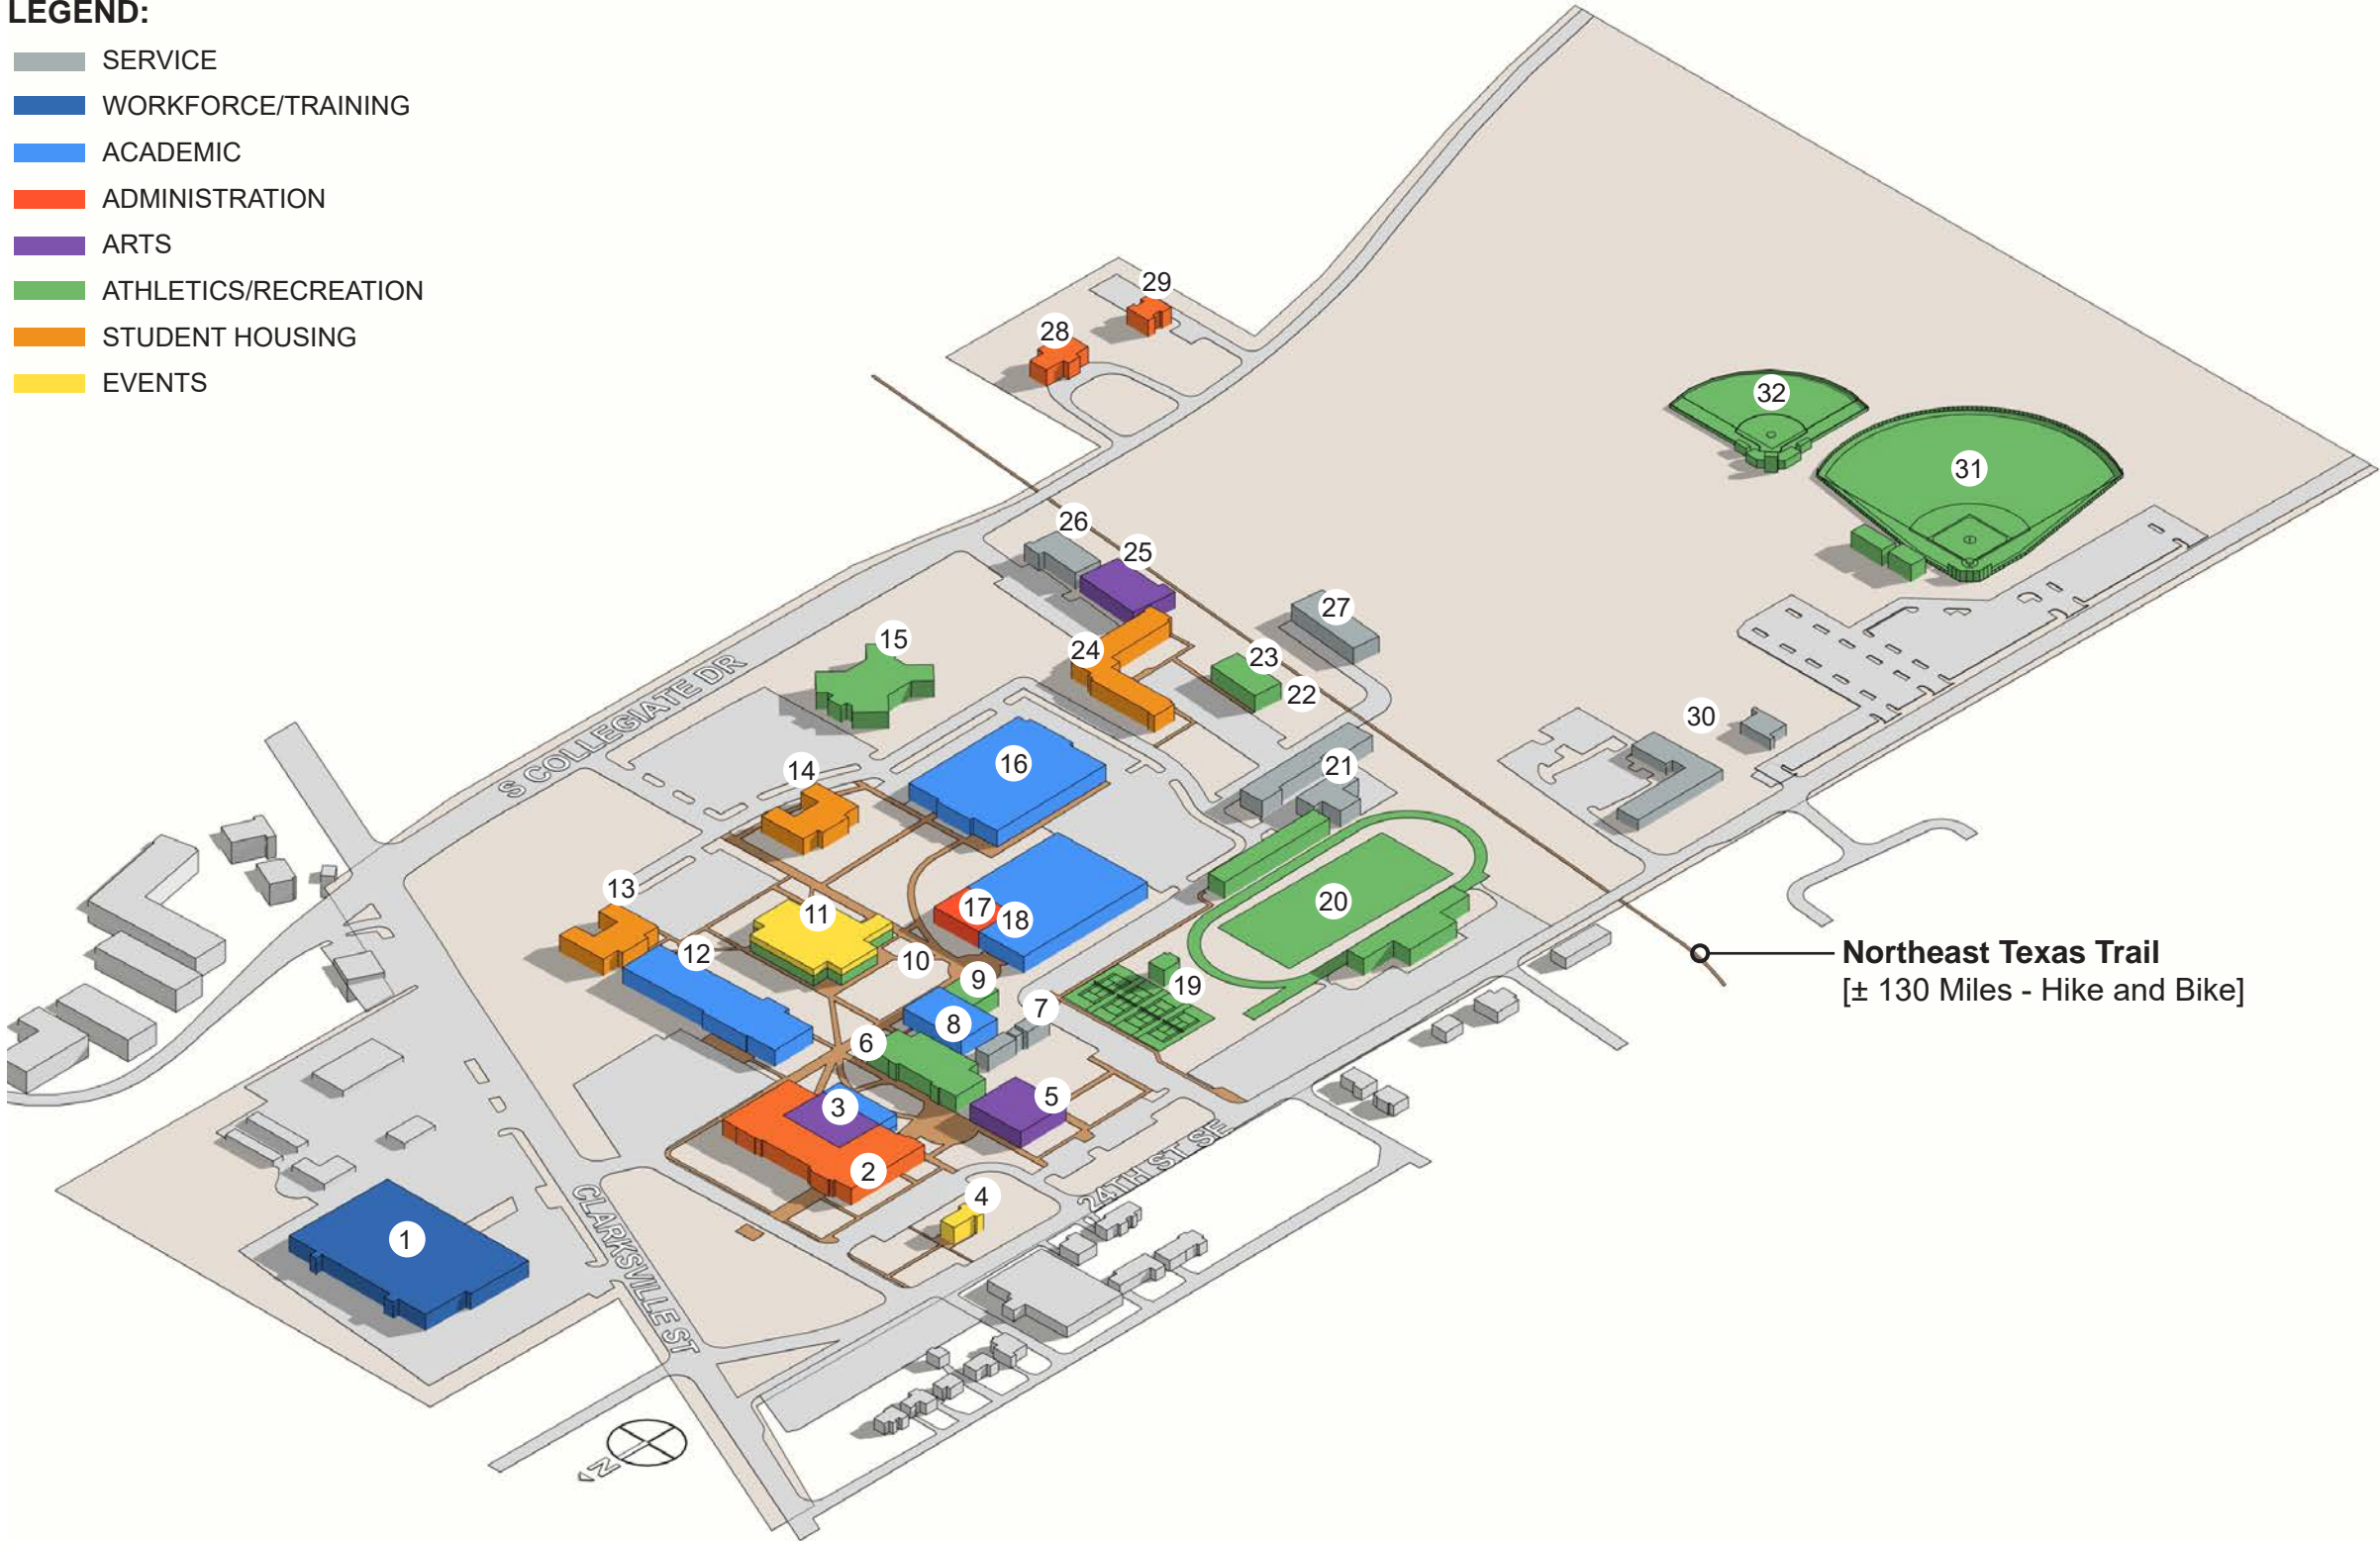
# DEPARTMENT LOCATIONS: PARIS CAMPUS

- LEGEND:**
- SERVICE
  - WORKFORCE/TRAINING
  - ACADEMIC
  - ADMINISTRATION
  - ARTS
  - ATHLETICS/RECREATION
  - STUDENT HOUSING
  - EVENTS

- EXISTING BUILDINGS:**
1. Bobby R. Walters Workforce Training Center
  2. Williams Administration Building (Ray E. Karrer Theatre)
  3. Frank Grimes Center

4. DeShong Chapel and Carillon Tower
  5. Mayer Center for Musical Arts
  6. Old Gymnasium
  7. Mechanical Building
  8. Alford Center
  9. College Store
  10. Aikin Plaza

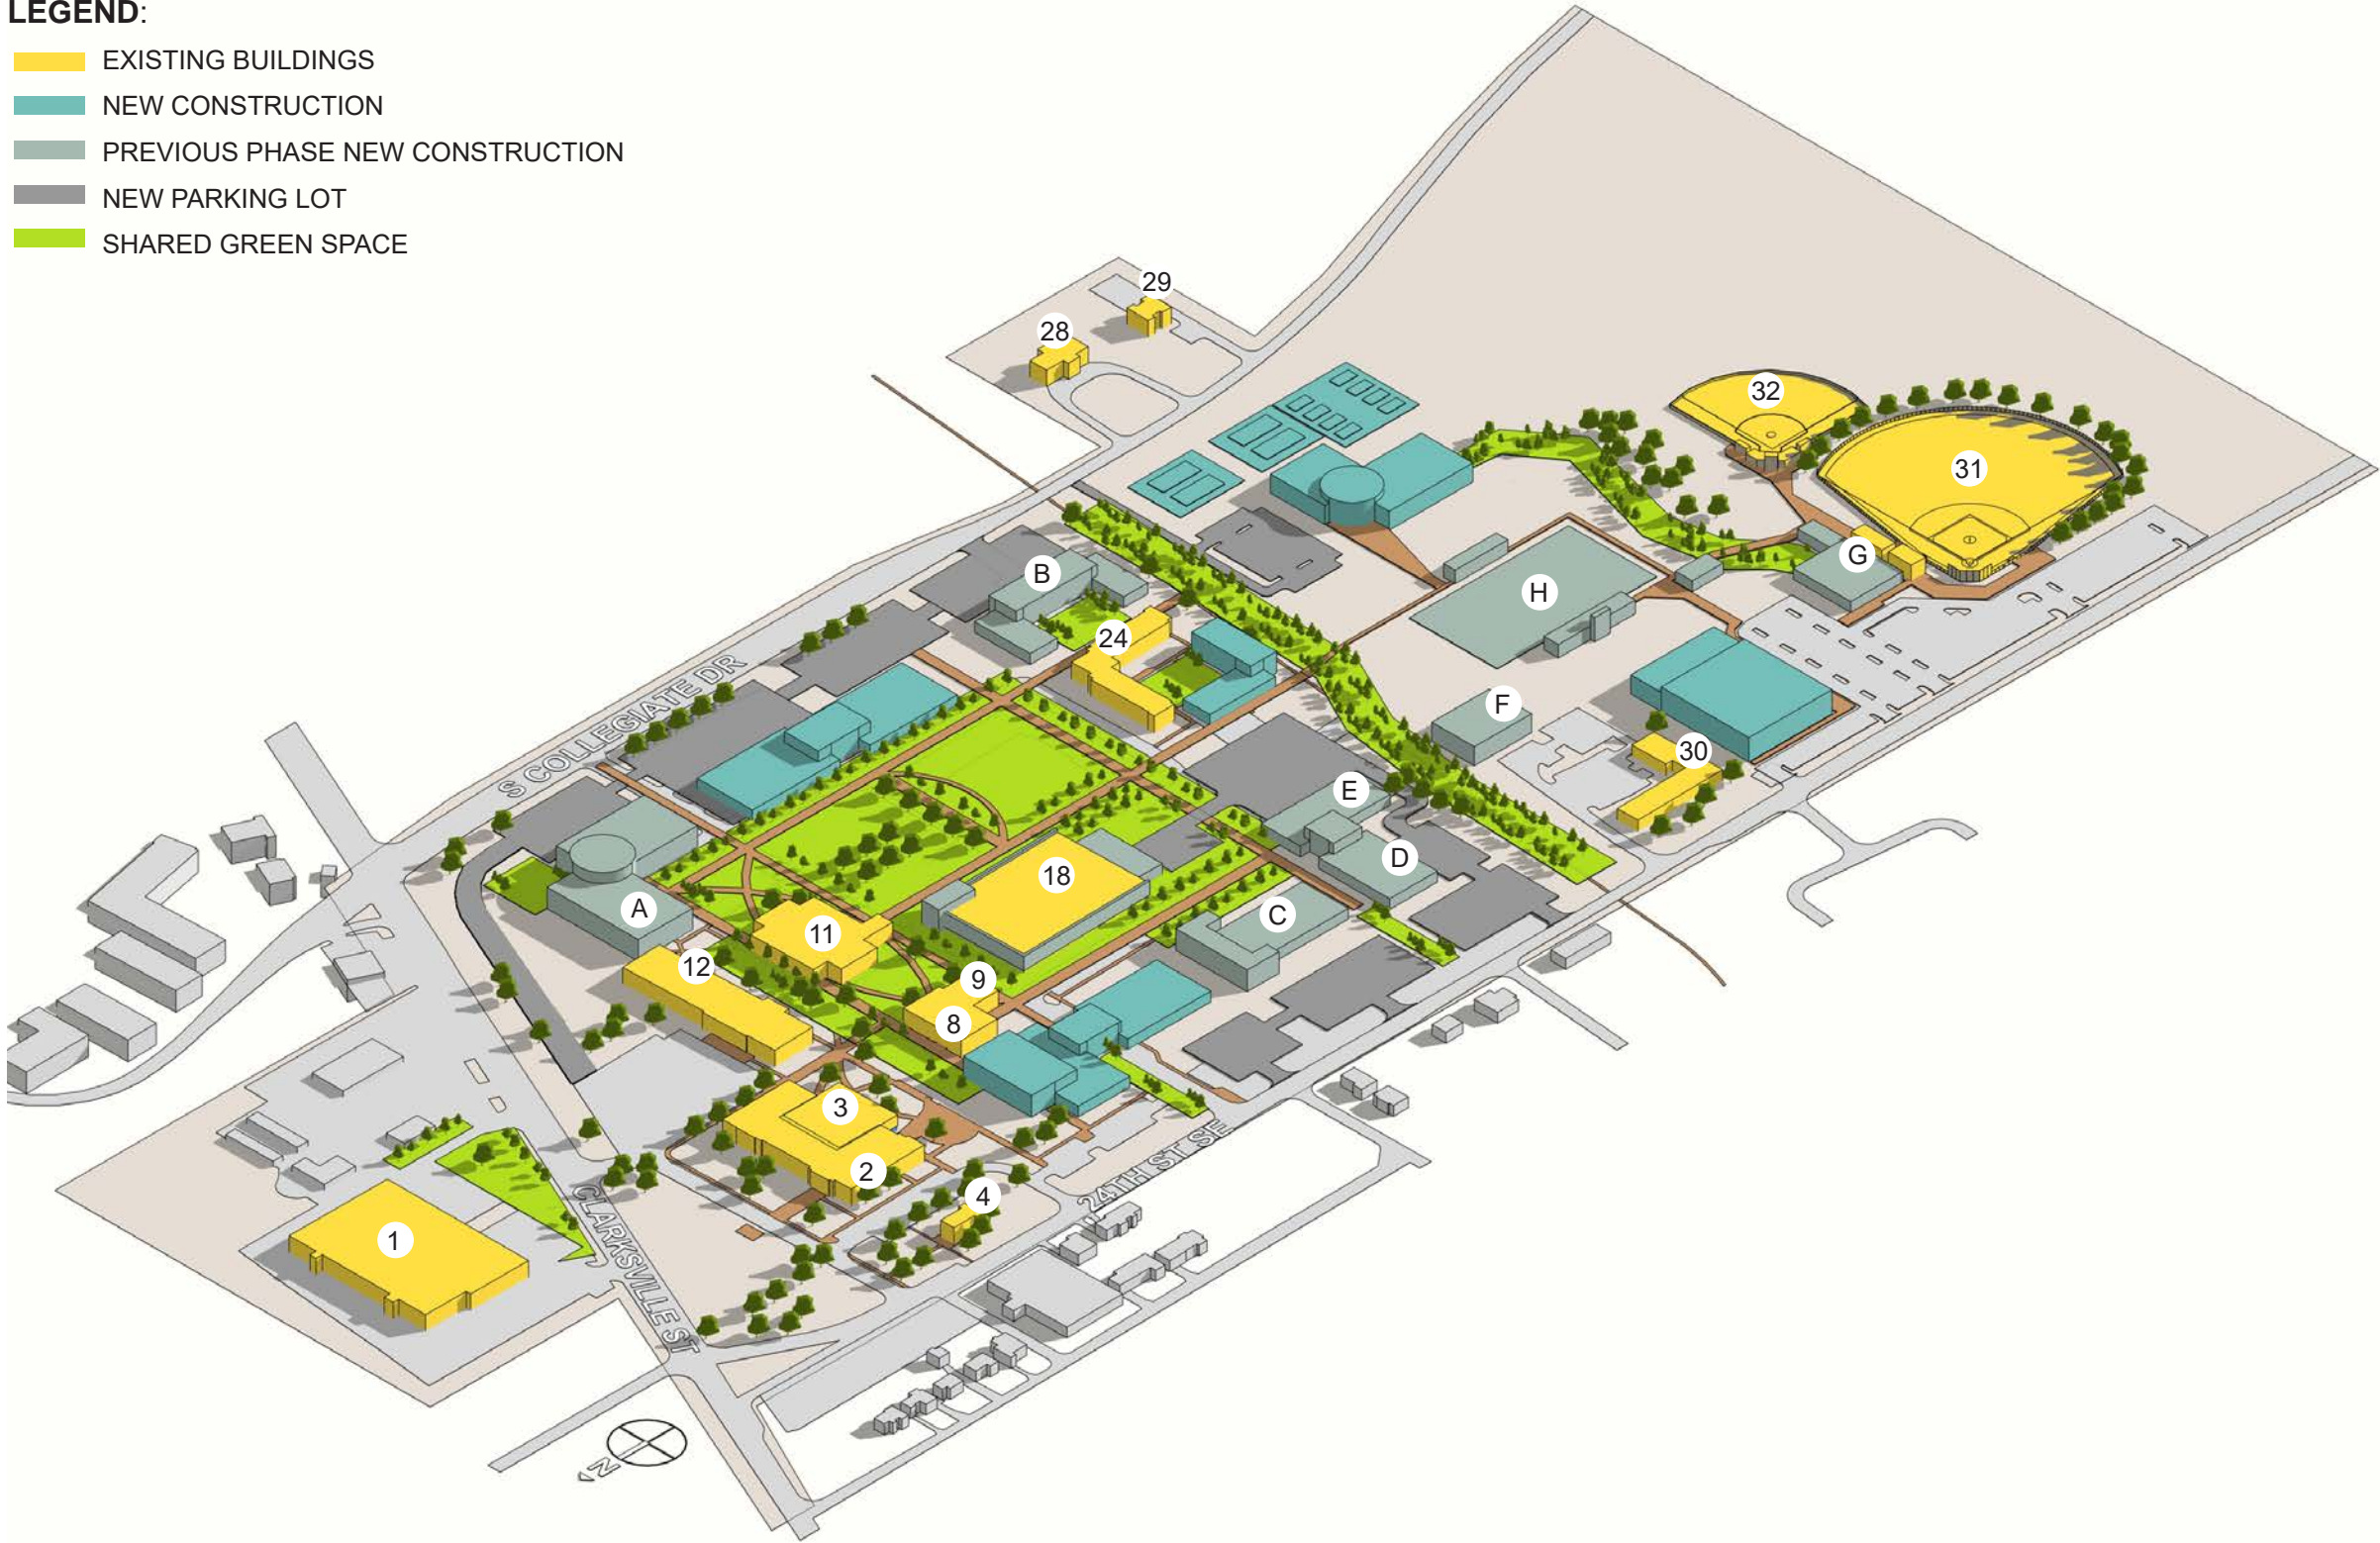
# GROWTH MASTER PLAN: NEW + REMAINING

- LEGEND:**
- EXISTING BUILDINGS
  - NEW CONSTRUCTION
  - PREVIOUS PHASE NEW CONSTRUCTION
  - NEW PARKING LOT
  - SHARED GREEN SPACE

- EXISTING BUILDINGS:**
1. Bobby R. Walters Workforce Training Center
  2. Williams Administration Building (Ray E. Karrer Theatre)
  3. Frank Grimes Center
  4. DeShong Chapel and Carillon Tower
  8. Alford Center
  9. College Store
  11. Alumni Center
  12. Math & Science Building
  18. Learning Commons & Student Union
  24. South Campus Residence Hall
  28. Talent Search/Upward Bound
  29. Gabbert Building/SBDC/RSVP
  30. Campus Services
  31. Hub Hollis Field
  32. Softball Field

- PREVIOUS PHASE BUILDINGS:**
- A. Allied Health
  - B. Student Housing
  - C. Public Safety and Campus Police
  - D. CTE Workforce
  - E. Visual Arts + Horology
  - F. Central Utility Plant
  - G. Field House
  - H. Sports Field

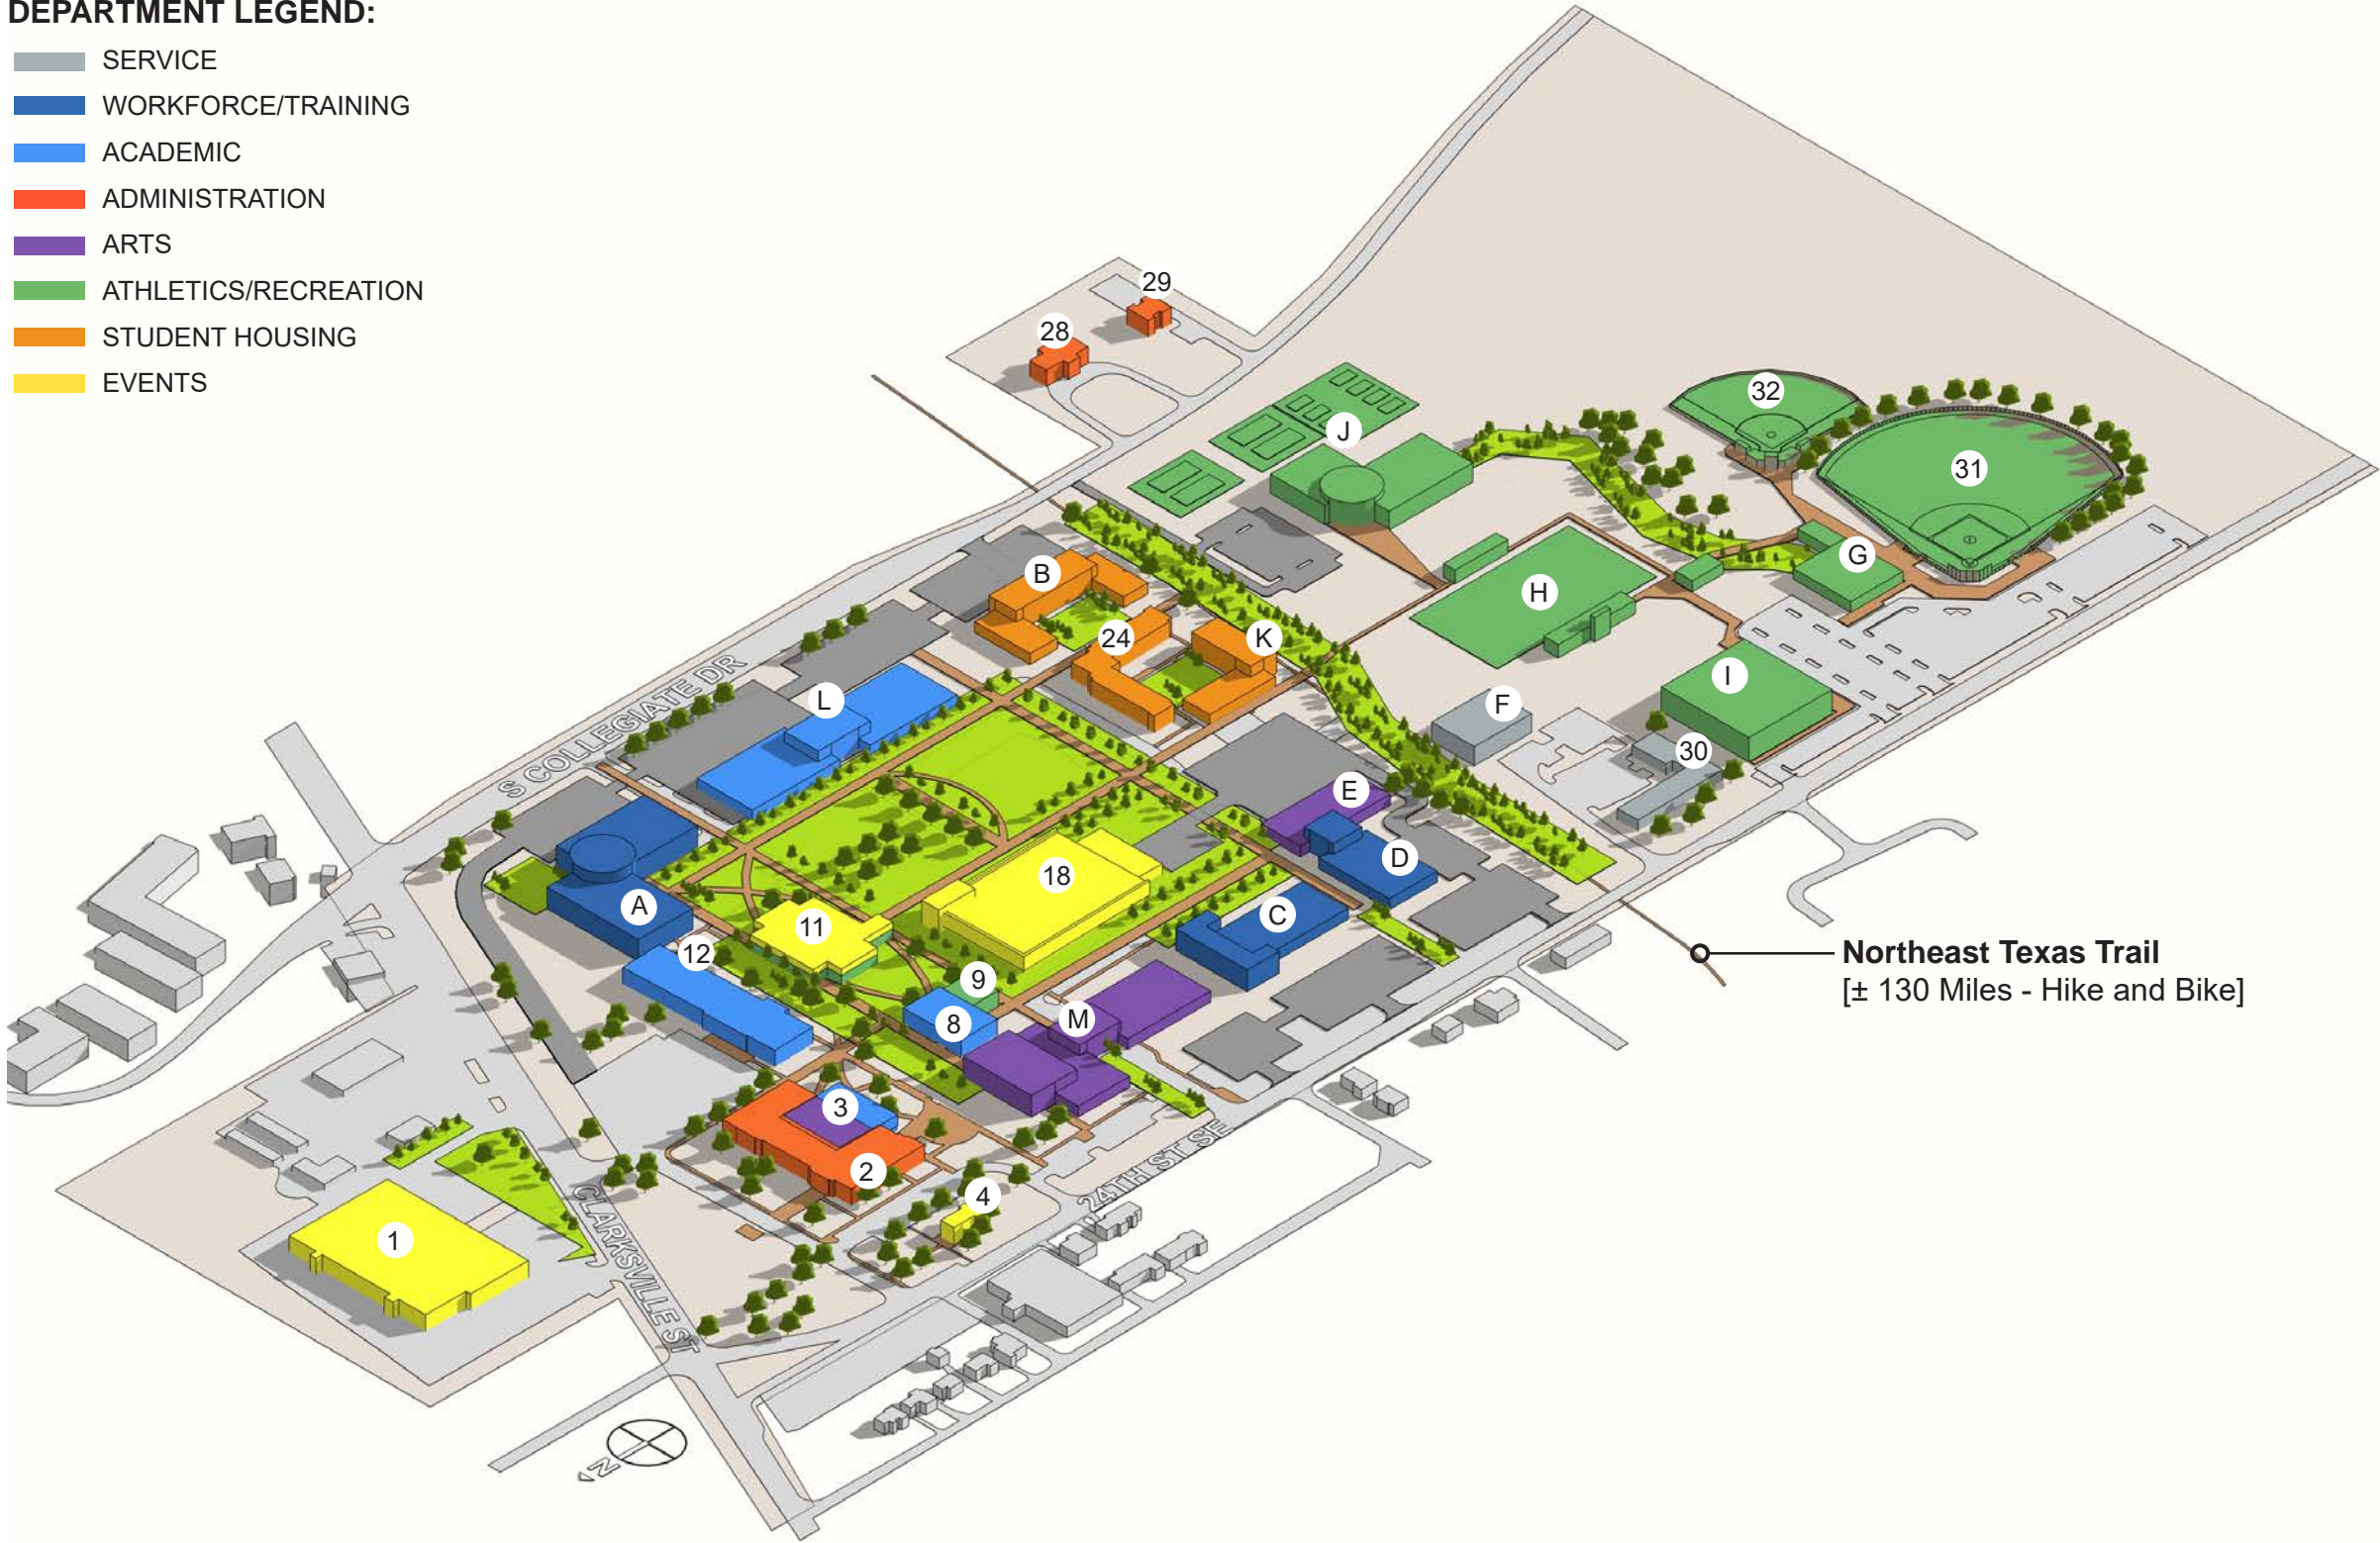
- A. Allied Health
- B. Student Housing
- C. Public Safety and Campus Police
- D. CTE Workforce
- E. Visual Arts + Horology
- F. Central Utility Plant
- G. Field House
- H. Sports Field
- I. Athletics Center
- J. Athletics: P/E Recreation
- K. Student Housing
- L. Academic Building
- M. Performing Arts

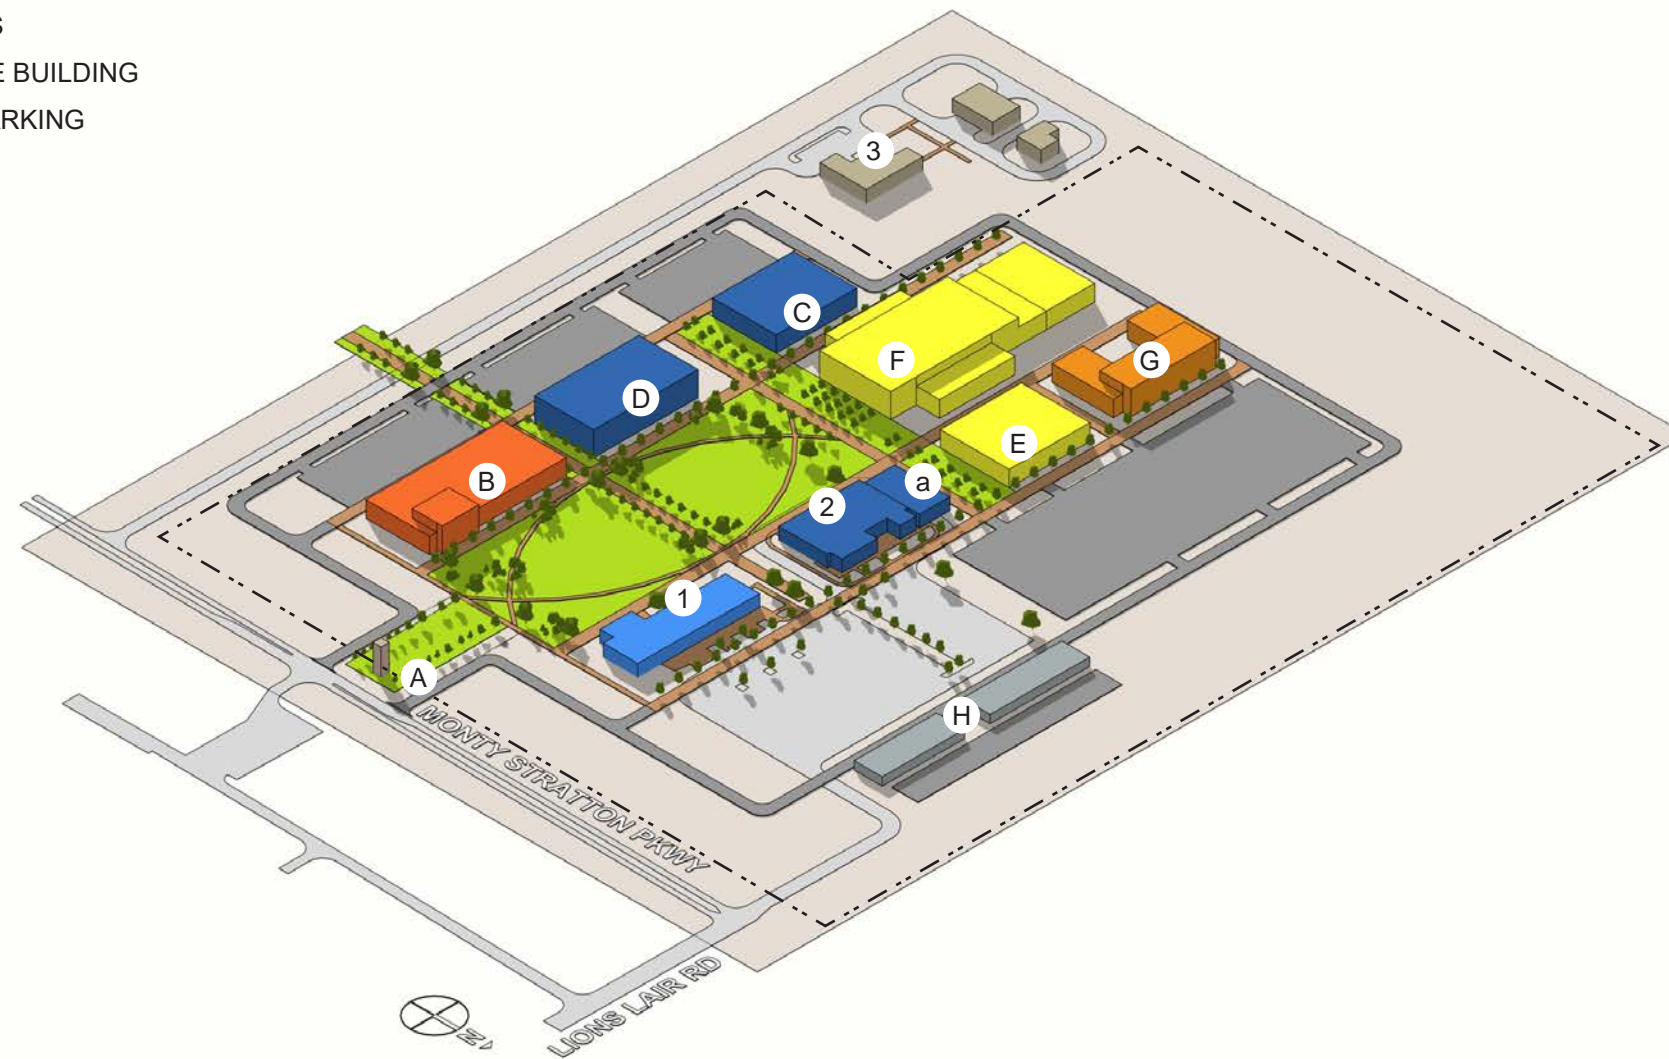
- SERVICE
- WORKFORCE/TRAINING
- ACADEMIC
- ADMINISTRATION
- ARTS
- ATHLETICS/RECREATION
- STUDENT HOUSING
- EVENTS
- FUTURE BUILDING
- NEW PARKING

- 2a. Workforce Bulding Addition
- A. Monumental Signage
- B. Central Administration Student
- C. Fire Academy + Campus Police
- D. Allied Health Center
- E. Learning Commons
- F. Student Housing
- G. Student Center
- H. Campus Services

- 1. Main Building
- 2. Workforce Building
- 3. City Fire Station
